**Admiralty Tough Chart 5**  
**SC5905 Chichester to Dungeness**

The Notices to Mariners (NMs) listed below apply to the latest edition of Tough Chart 5 (SC5905) (1<sup>st</sup> Edition) published on 23<sup>rd</sup> August 2007.

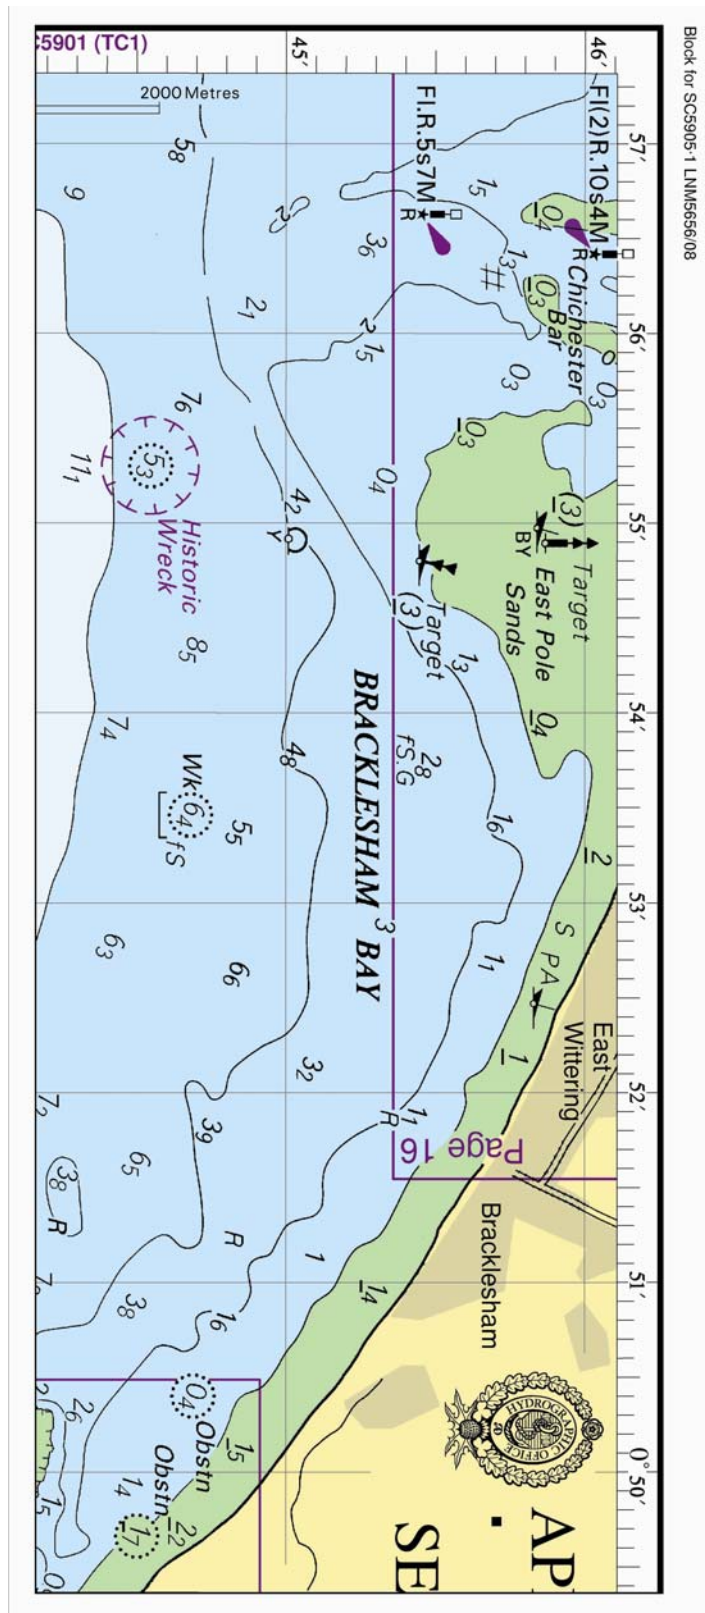
**Chart: SC5905-1 ETRS89 DATUM**

**L5656/08 ENGLAND — South Coast — Approaches to Chichester Harbour — Light-beacons. Recommended track. Leading line. Depths. Tidal gauges.**

Insert the accompanying block, showing amendments to light-beacons, recommended track and depths, centred on: 50° 45' 20N. , 0° 53' 50W.

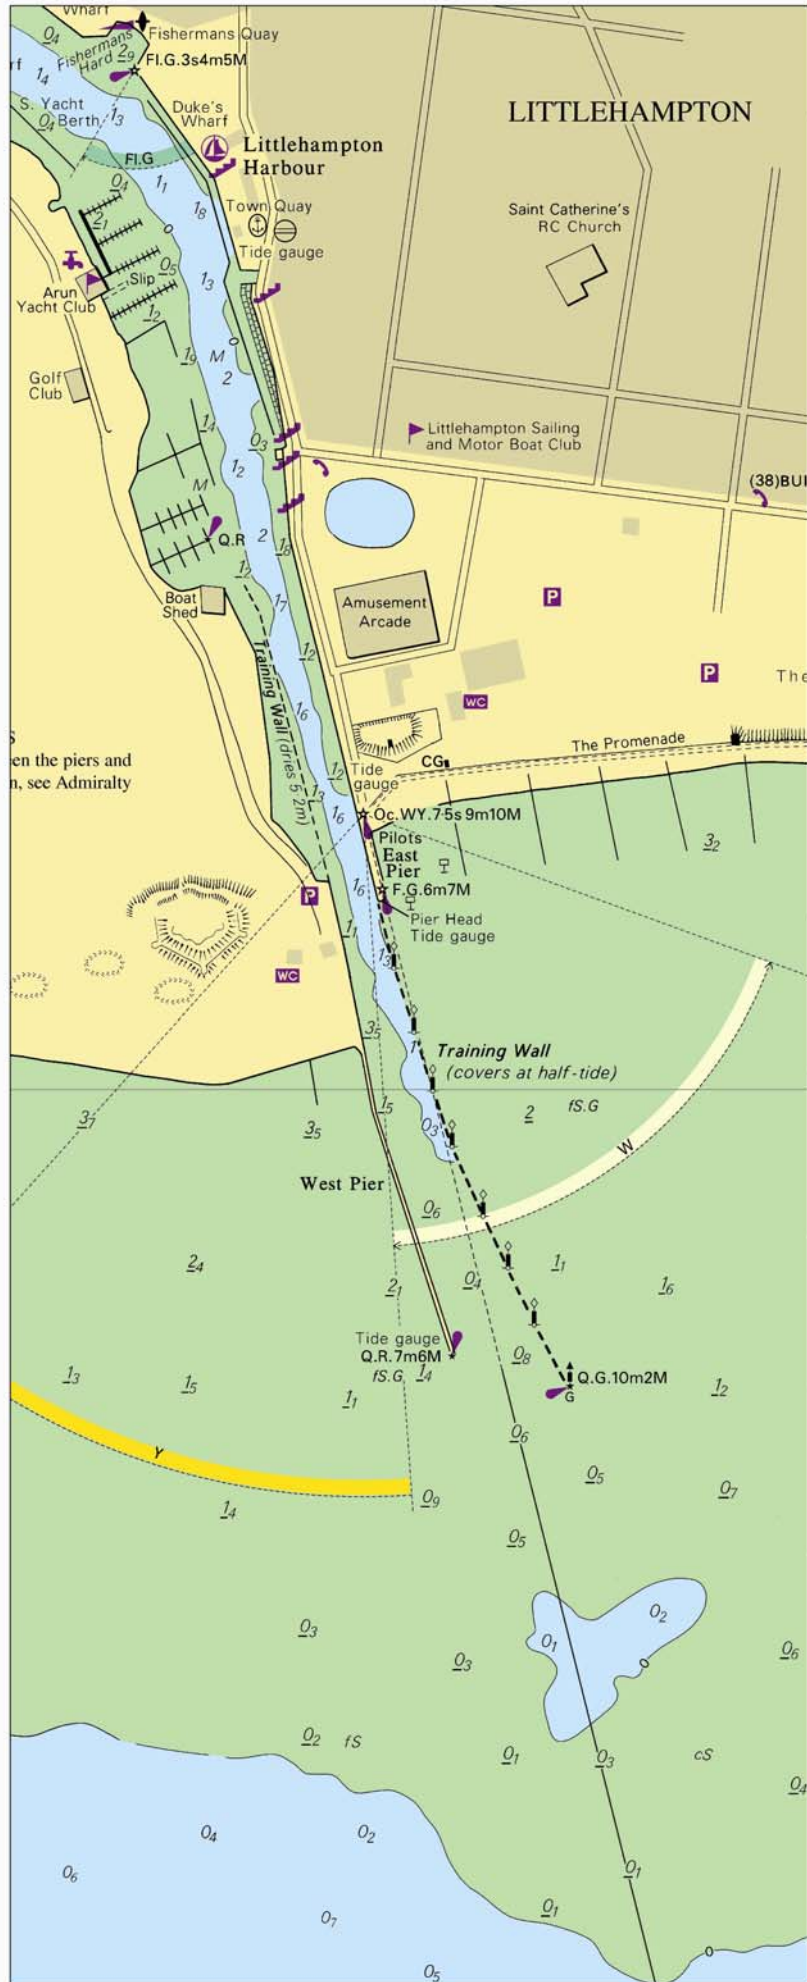
**Chart: SC5905-17 ETRS89 DATUM**

Insert the accompanying block, showing amendments to depths,  
pontoons and a light, centred on:

50° 48' ·04N. , 0° 32' ·49W.
